TEST REPORT

Report No.: HC80219A/2016 Page: 1 of 9 Date: September 6, 2016

The following merchandi	se was submitted and identified by the vendor as:
Product Description:	Detection of Shockindicator and Tiltindicator
Style/ Item No.:	25G Shockindicator (Yellow Label)/ No.1 ~ No.5;
	37G Shockindicator (Purple Label)/ No.1 ~ No.5;
	50G Shockindicator (Red Label)/ No.1 ~ No.5;
	75G Shockindicator (Orange Label)/ No.1 ~ No.5;
	100G Shockindicator (Green Label)/ No.1 ~ No.5;
	Tiltindicator/ No.1
Manufacturer/ Vendor:	Shockindicator Enterprise Co., Ltd.
Country of Origin:	Taiwan
Quantity:	Total 26 pieces
Testing Period:	Aug. 29, 2016

- 1. Drop Test
- 2. Tilt Test

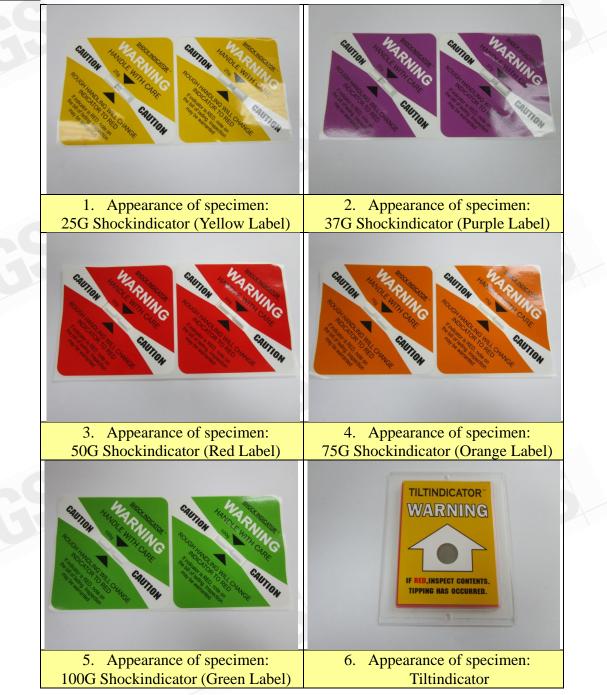
Test Photos:

Check Item		
Style/ Item No.	Drop Height	Whether the indicator of specimen change color or not?	Note
25G Shockindicator (Yellow Label)/ No.1		Yes (See photo 8)	
25G Shockindicator (Yellow Label)/ No.2		Yes (Same as photo 8)	
25G Shockindicator (Yellow Label)/ No.3	30 cm	Yes (Same as photo 8)	Wooden Box (1)
25G Shockindicator (Yellow Label)/ No.4	GUC	Yes (Same as photo 8)	
25G Shockindicator (Yellow Label)/ No.5		Yes (Same as photo 8)	
37G Shockindicator (Purple Label)/ No.1		Yes (See photo 10)	C
37G Shockindicator (Purple Label)/ No.2		Yes (Same as photo 10)	
37G Shockindicator (Purple Label)/ No.3	40 cm	Yes (Same as photo 10)	Wooden Box (1)
37G Shockindicator (Purple Label)/ No.4		Yes (Same as photo 10)	
37G Shockindicator (Purple Label)/ No.5	C	Yes (Same as photo 10)

1000 Legaspinente			
Name	Brand	Model	Serial No.
Drop Tester	King Design	KD-128A	WR112197097
Lab Environmental Cond	itions:		
Ambient temperature:	<u>(25 ± 3) °C</u>		
Ambient humidity:	(55 ± 20) % RH		
Test Method/ Specification	_		
Sample condition:	Stick with wooden box		
Carton size:	(1) L: <u>600 mm</u> W: <u>500 mm</u> H: <u>500 mm</u>		
	(2) L: <u>450 mm</u> W: <u>280 mm</u> H: <u>330 mm</u>		
Wooden Box Weight:	(1) <u>40 kg</u>		
	(2) <u>20 kg</u>		
Drop height:	<u>30 cm, 40 cm, 60 cm, 90 cm, 120 cm</u>		
Test surface:	Steel plate of 1cm thickness
